PROJECT REPRESENTATIVE'S DAILY REPORT

Pg. 1
Report No. 025
Date: 2014-09-22
Day: Monday

Project: Renovation and Addition to Tewksbury Town Hall

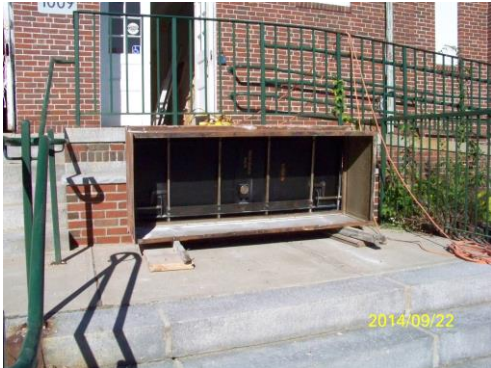
Photo showing a removed safe door and frame.

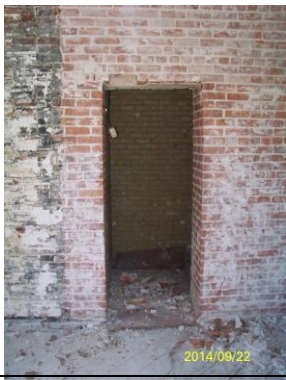
Photo showing masonry opening where safe door was located.

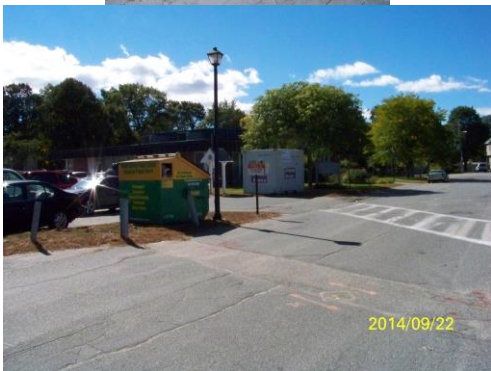
Photo showing box and recycling container in their relocated positions.

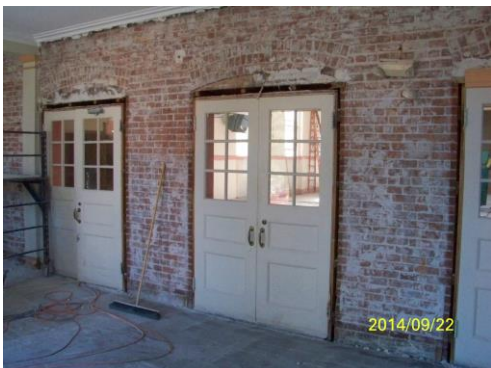
Photo showing the lobby walls with the finished removed.

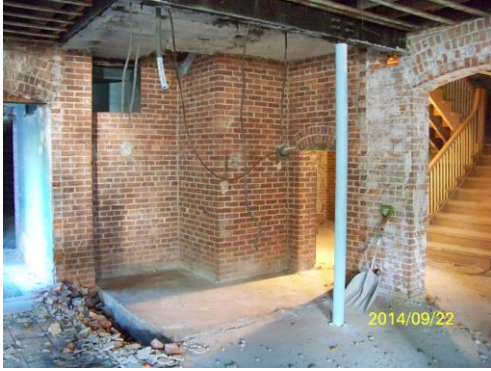
Photo showing one of the storage rooms with the masonry wall removed.

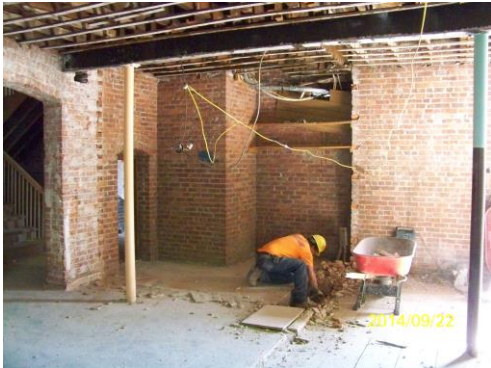
Photo showing the other storage room with the masonry wall removed.

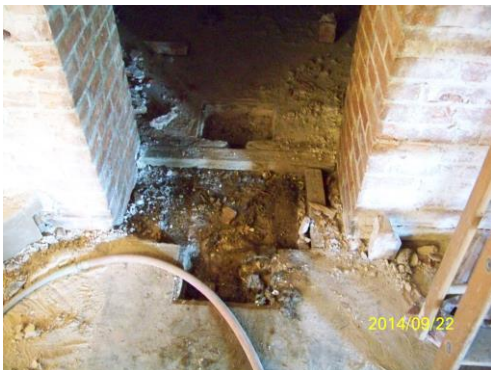
Photo showing the basement vault with door and grates removed.

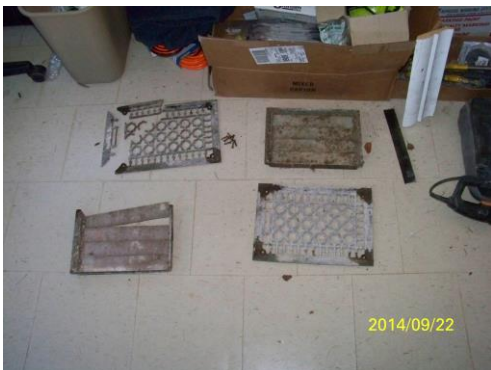
- 4) The safe door and frame from the basement has been removed.
- 5) The floor grates from the basement vault have been removed. One had a hairline crack and broke apart during the removal process.

Photo showing the floor grates removed. One suffered a hairline crack and broke during the removal process.

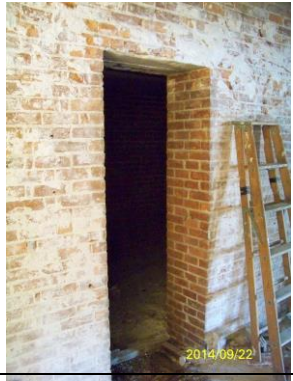
Photo showing the basement vault door and frame removed.

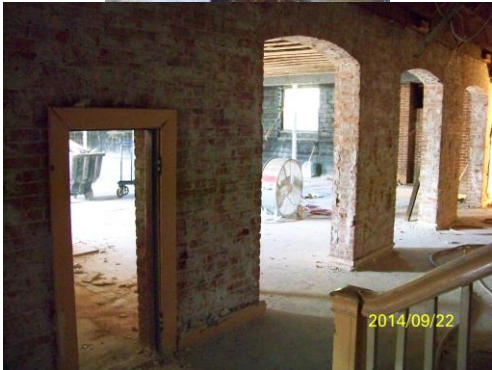
Photo showing the basement hallway at the bottom of the south stairs, looking northwest.
